# Report for 2002GA7B: RESERVOIR SHORELINE EROSION AND SEDIMENTATION ANALYSIS:

## **Field Observations for Definition of**

# **Reservoir Shoreline Erosion and Sedimentation:**

Lake Hartwell, SC/GA

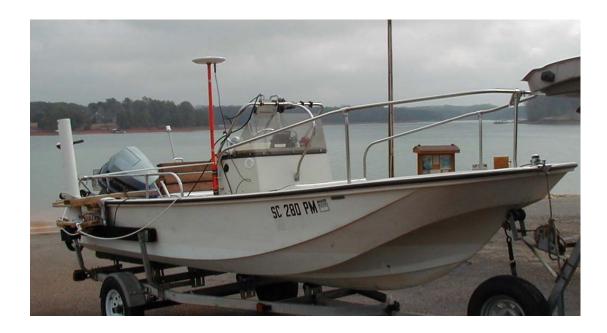
Figure 6. Boat used for data collection

A survey system shown in Figure 6 was used to collect hydrographic survey data. The survey system was mounted on a Boston Whaler 17 foot fiberglass boat. Depth data were provided by a dual frequency depth measuring system (high frequency 200 kHz, low frequency 30kHz), Digital Echo Sounder Ceestar, manufactured by Bruttour Int. Figure 7 shows the mounting of the depth sounder. Digital depth data were directly logged to a laptop computer equipped with Coastal Oceanographic's HYPACK Hydrographic Survey Software. Data were output and stored at a rate of 6 soundings / sec.

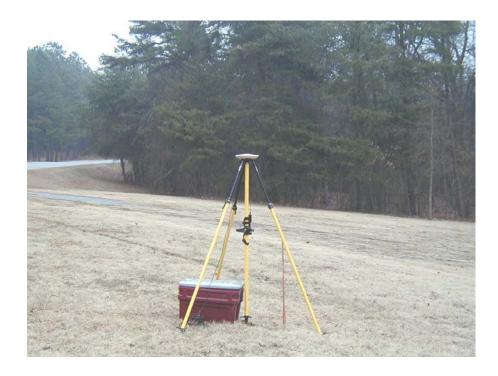
Figure 16. Base station set up at Sadlers Creek State Park.

The base station was set at a National Geodetic Survey monumented benchmark located at Sadlers Creek State Park, in Anderson County, SC (Table 4, Figure 16).

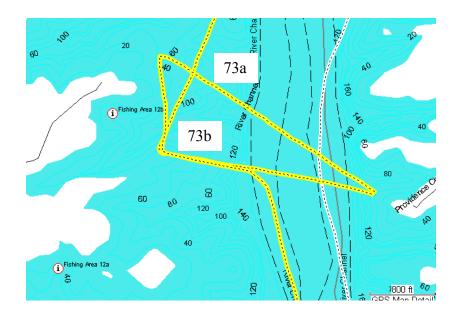
Figure 20. Topography map for transect 73.

A resurvey of transect 73 with a different route (shown by 73b in Figure 20) indicated that deviating from the route did not introduce significant errors to the thalweg elevation estimates. The survey results from two different routes are compared in Figure 21.

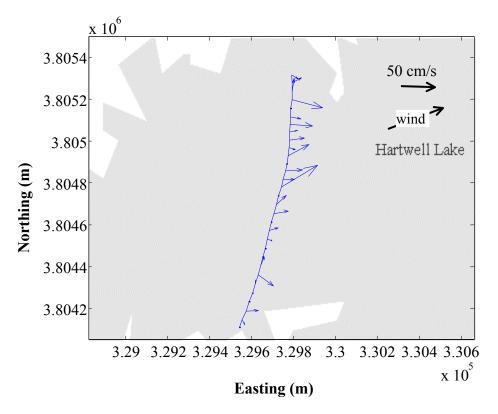
Figure 34. Near-surface velocity vectors measured at transect #3 shown in Figure 15.

Measured near-surface velocities at the other three transects (#2, #3, and #4) are shown in Figures 33, 34 and 35 respectively. In all three cases, maximum measured velocities are ~50 cm/s and average velocities are ~25 cm/s. One rule of thumb for wind-
